Aviation Occurrence Investigation – AO-2009-012
Interim Factual Report

**Tailstrike
Melbourne Airport, Vic.
20 March 2009
A6-ERG
Airbus A340-541**

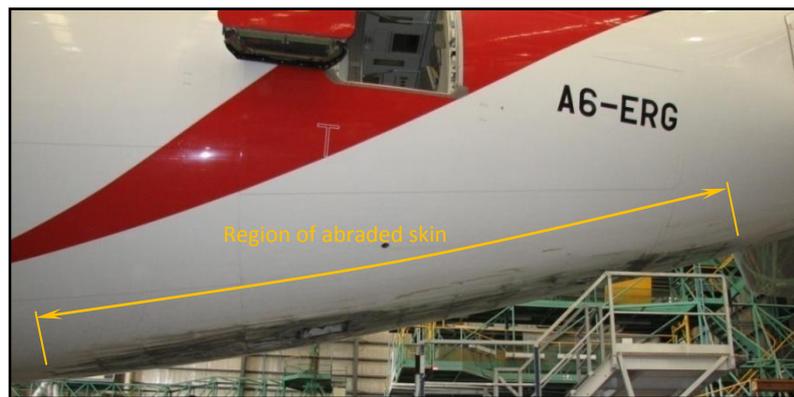
Figure 1: Skin abrasion

An initial inspection of the aircraft revealed that the rear of the fuselage was seriously damaged¹². The lower skin panels were abraded by contact with the runway surface (Figure 1), and in some areas the skin had worn through the full thickness (Figure 2). A service panel had been dislodged (Figure 2) and was found by airport personnel at the end of the runway, along with numerous pieces of metal

Temporary repairs were carried out in Melbourne by the aircraft manufacturer and the aircraft was flown to France for further engineering work to be carried out by the manufacturer.

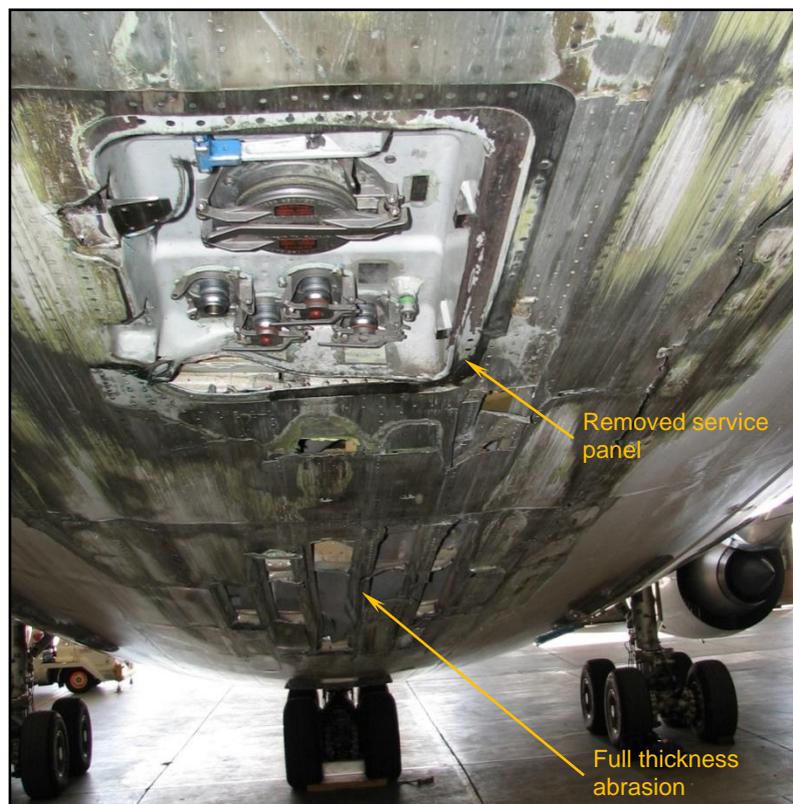
Figure 2: Skin abrasion detail

consistent with the abraded skin panels. Numerous fuselage frames and stringers in the region were deformed and several contained cracks (Figure 3). The rear pressure bulkhead¹³ contained cracks in the composite structure and deformation of the diaphragm support ring (Figure 4). There were also scrapes on the right side of the fuselage consistent with contact with external objects. One contact mark had an orange colouration and was located forward of the skin abrasion, immediately below the right-rear cargo door (Figure 5). The other contact mark was located adjacent to the skin abrasion and consisted of several, fine, divergent marks running rearwards and slightly upwards (Figure 6). There was also a contact mark on the left main landing gear, inboard-rear tyre (Figure 7).

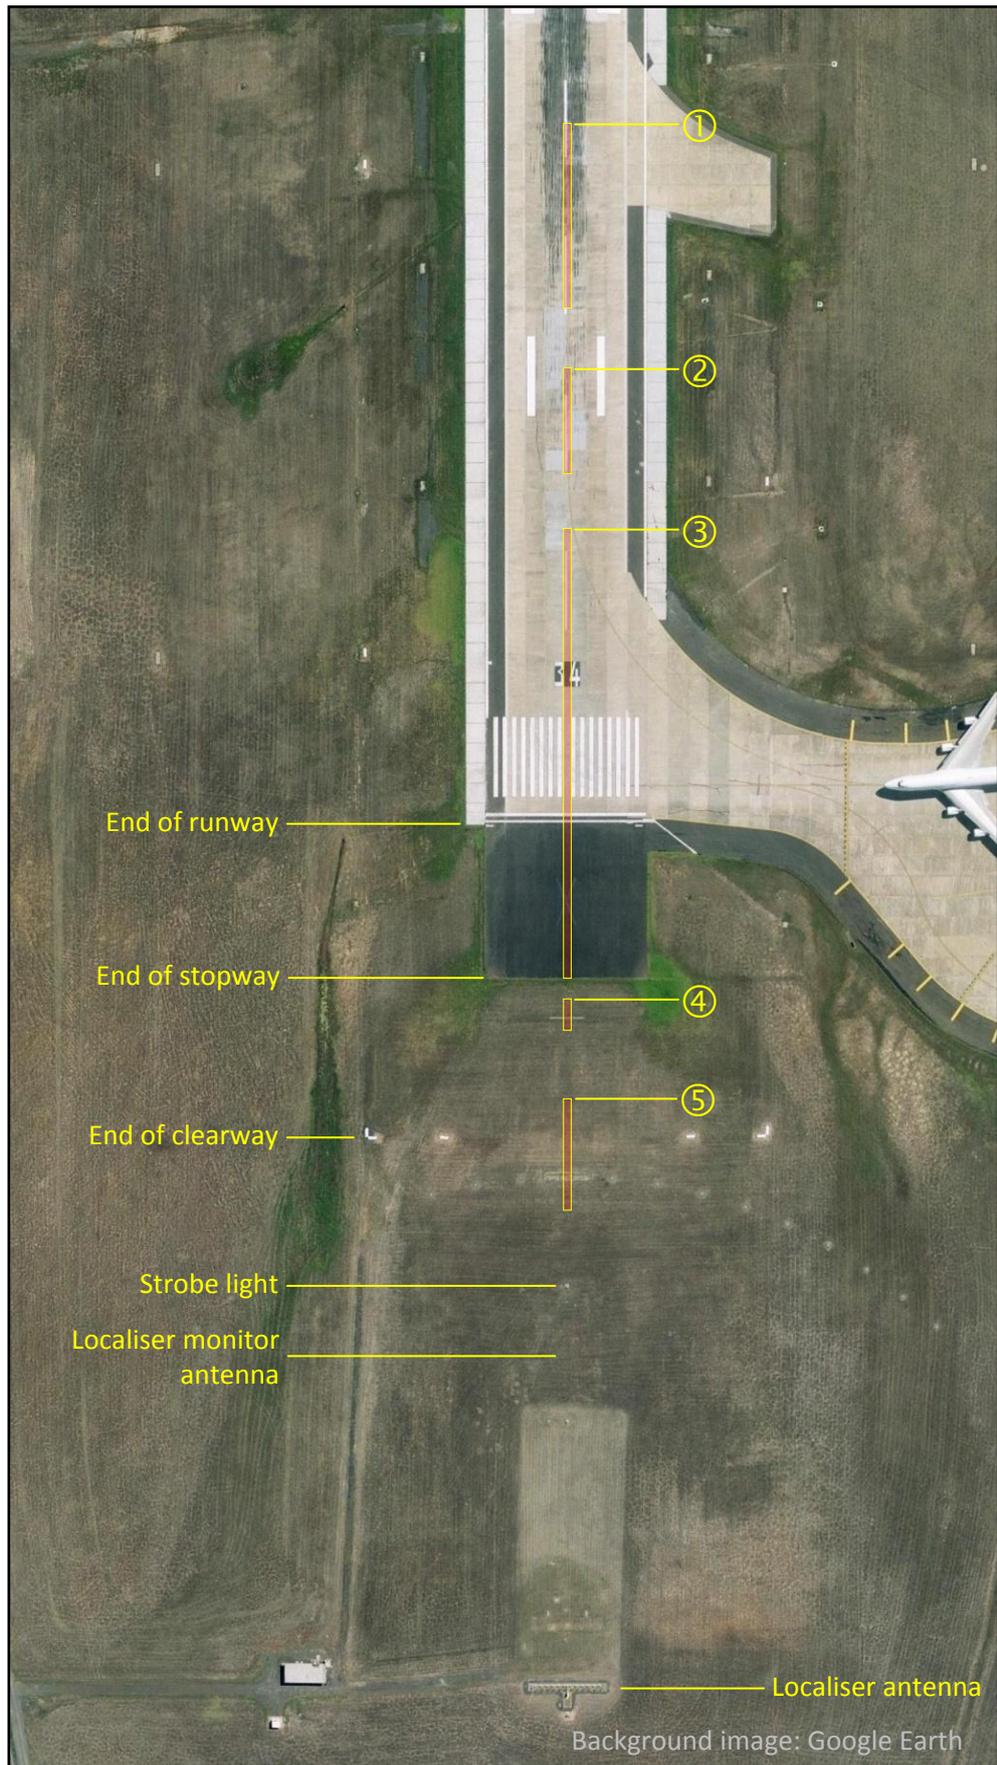
Figure 8: Ground contact marks

An inspection of the runway and overrun areas identified multiple contact marks (Figure 8). The tail of the aircraft made contact with the runway at three locations, each starting at the positions indicated by ① ② and ③ in Figure 8. After leaving the stopway, two contact marks were identified in the grassed area, indicated by ④ and ⑤ in Figure 8. Figure 9 shows typical ground contact marks. The aircraft also made contact with ground infrastructure; a runway 34 sequenced lead-in strobe light (Figure 10), and the runway 16 localiser monitor antenna (Figure 11). The damage to the runway 16 localiser antenna (Figure 12) was consistent with the contact mark on the left main landing gear inboard-rear tyre. The resulting damage to the antennas disabled the localiser function.

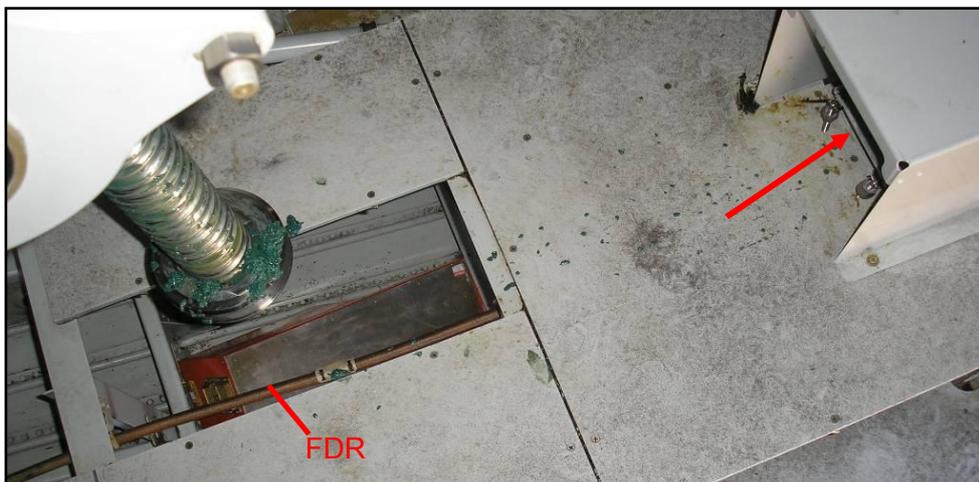
The examination and retrieval of the flight recorders was undertaken under Australian Transport Safety Bureau (ATSB) supervision on 21 March 2009. The FDR had separated from its mounting rack and was located in a small compartment directly to the rear of the mounting rack and adjacent to the tail lower skin (Figure 25).

Figure 25: Location of FDR as found with FDR mounting rack in view (arrowed)

The FDR mounting rack displayed evidence of deformation with part of one securing nut found to have separated from the rack. The CVR and DAR PC-card were in their correct locations and undamaged.

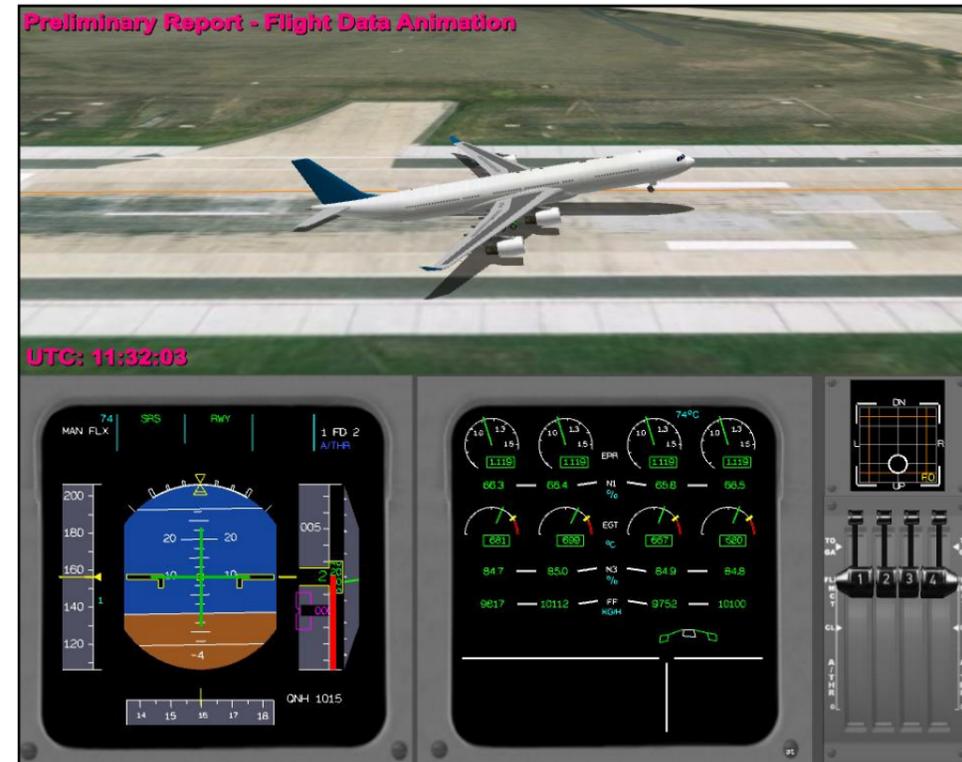
Figure B2: Initial tail contact with the runway

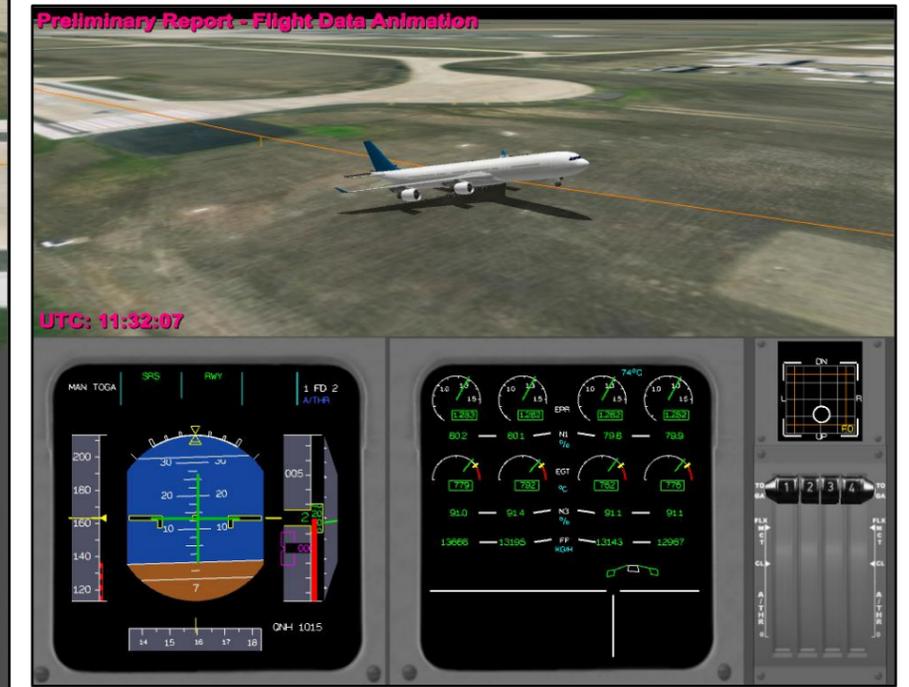
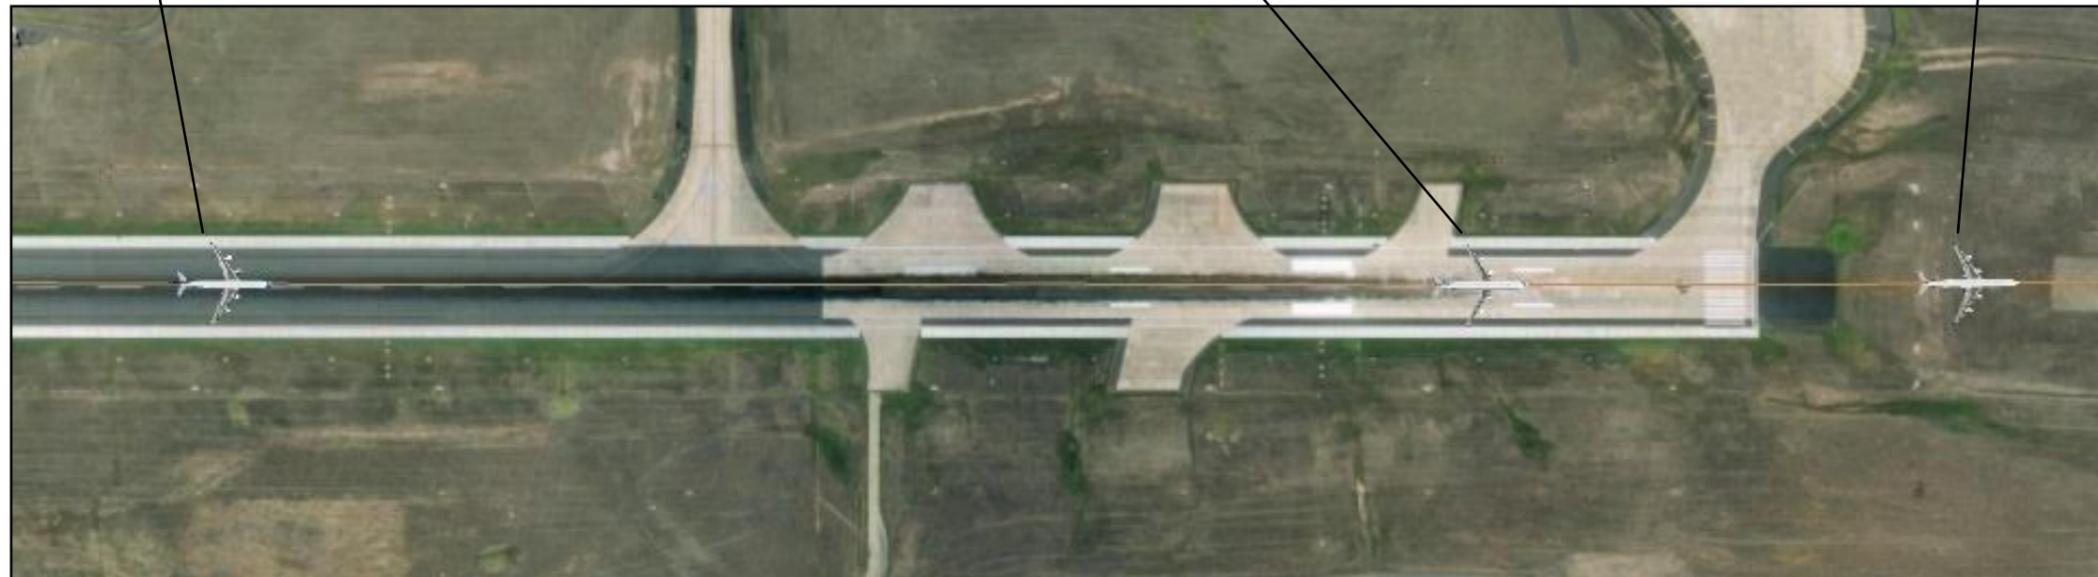
Figure B3: Final tail ground contact witness mark
