Aviation Occurrence Investigation – AO-2009-012
Interim Factual Report

**Tailstrike
Melbourne Airport, Vic.
20 March 2009
A6-ERG
Airbus A340-541**

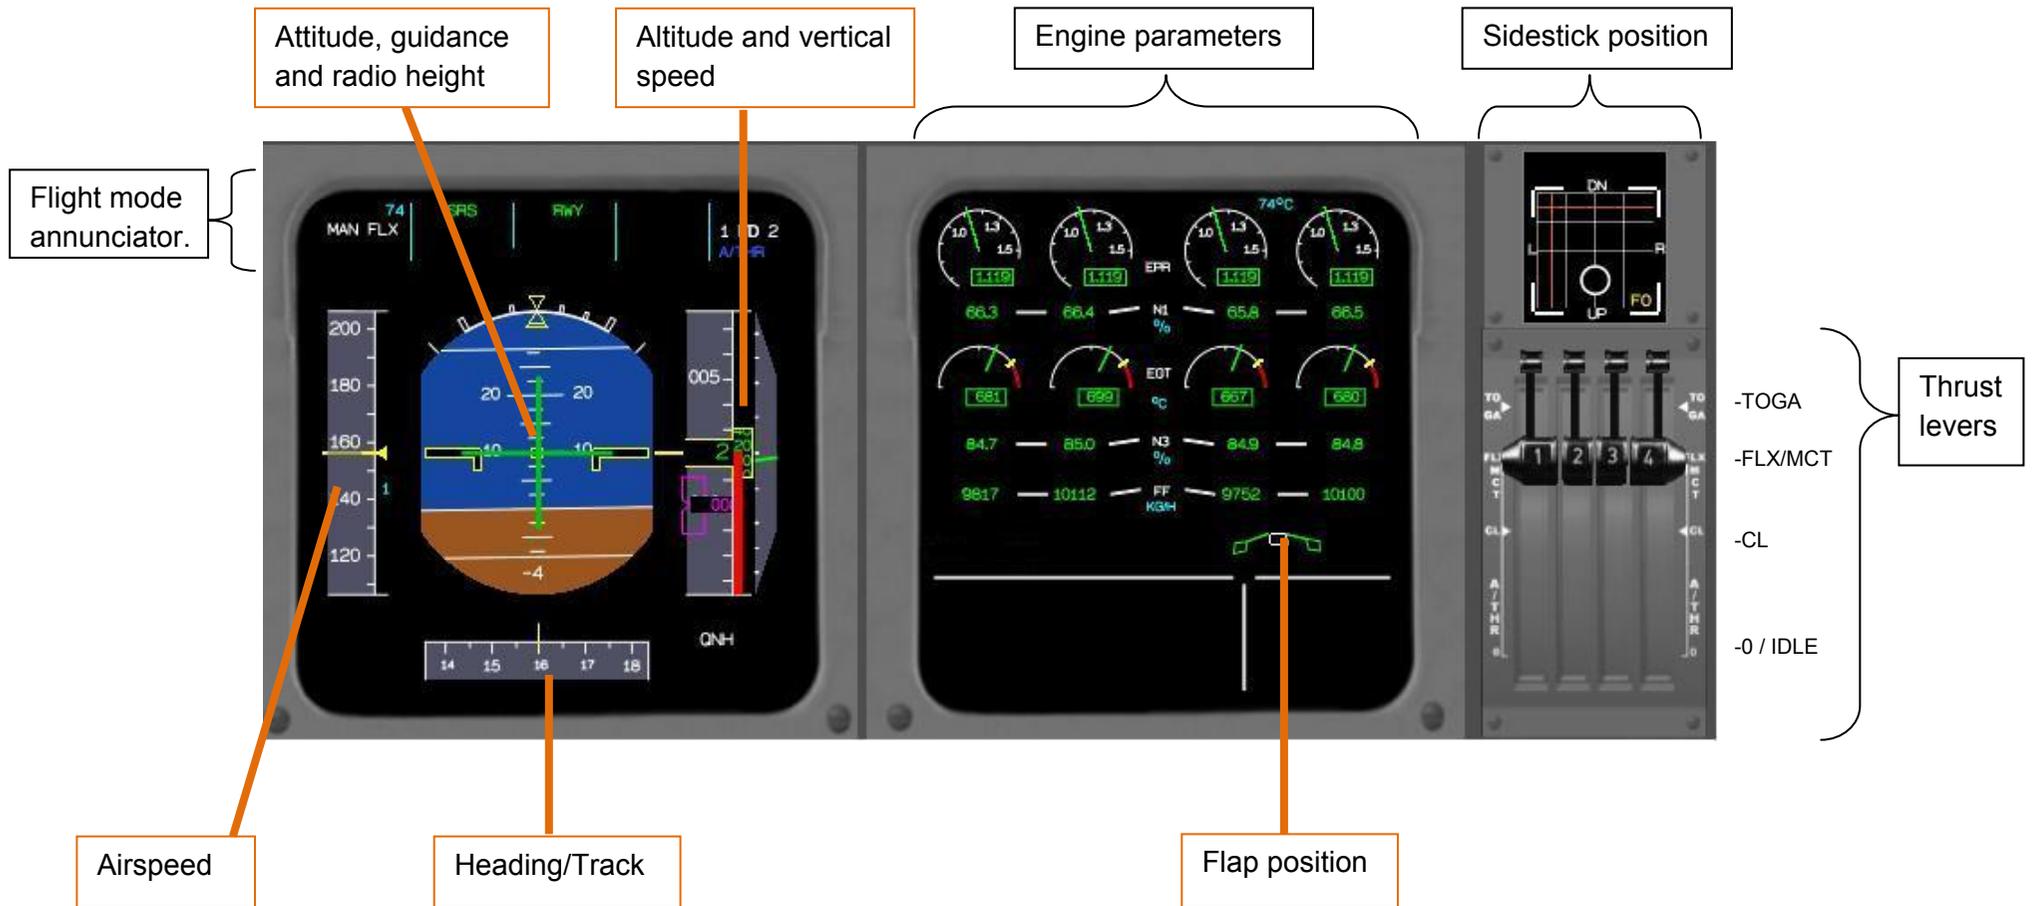
Figure B5: Diagram depicting the parameters as displayed on Figures B1 to B3

Figure B4: Graphical representation of the DAR data showing the position of the aircraft at a computed airspeed corresponding to V_1 as used by the crew, initial tail contact with ground, and final tail ground contact witness mark.
